POTHUNTING IN CENTRAL ARIZONA: THE PERRY MESA ARCHEOLOGICAL SITE VANDALISM STUDY

SWCA, INC. TUCSON, AZ

SEP 1992

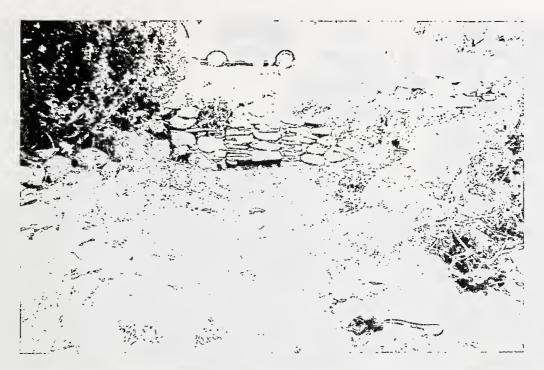
Figure 44. Looking south at a pot-hunted room in Mound A, Site AR-03-12-01-44 from Photo Station a in 1968. Note the accumulation of fill against the wall. MNA Photo 9875.2

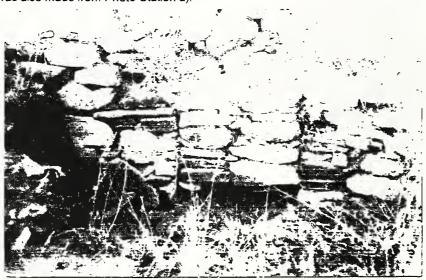
Figure 47. Looking south at an exposed wall in Mound A, Site AR-03-12-01-44 from Photo Station b. Photo 67-2-28 by Peter J. Pilles, Jr.

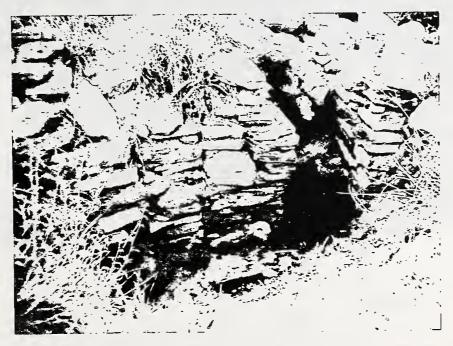
Figure 49. Looking east-southeast from Photo Station c at a pot-hunted room in Mound A, Site AR-03-12-01-44. MNA Photo 9875.3 dated 1968.

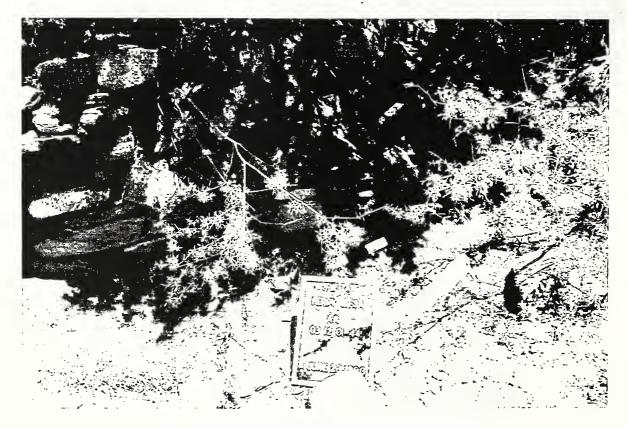
Figure 51. Looking east-southeast from Photo Station c at a pot-hunted room in Mound A, Site AR-03-12-01-44. Note the doorway and filling of hole to left. PMSVS Photo 10.13 dated 1990.

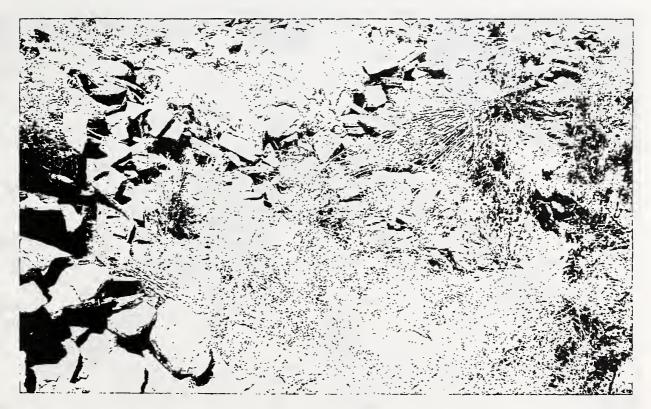
Figure 57. Looking north-northeast from Photo Station e at a pot hunted room in Mound A, Site AR-03-12-01-44. Compare to Figures 55 and 56. This PMSVS Photo (10.16) was made in 1990.

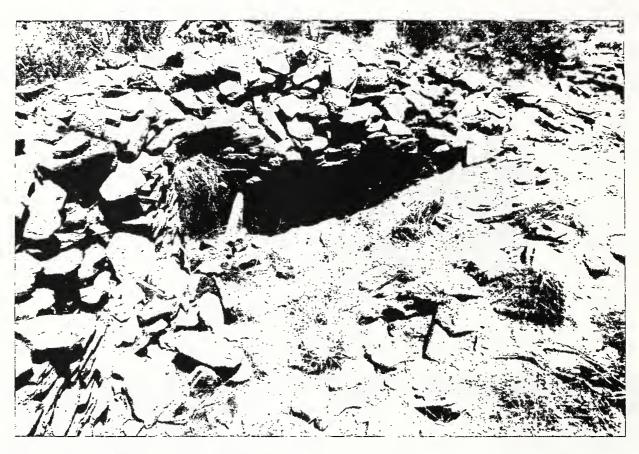
Figure 62. Compare this 1990 PMSVS Photo (number 10.21) of a pot-hunted room in Mound A, Site AR-03-12-01-44 with Figures 60 and 61 on page 129.

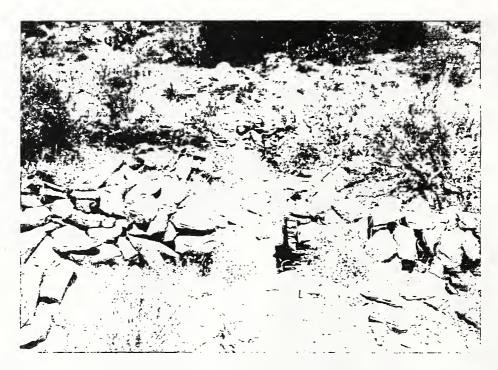
Figure 65. Looking east at pot hunted Mound A, Site AR-03-12-01-44 from Photo Station m. Digging in the area in front of and behind the door in foreground was attributed to Jones, Jones, and Gevara. This 1990 PMSVS photo is number 10.30.

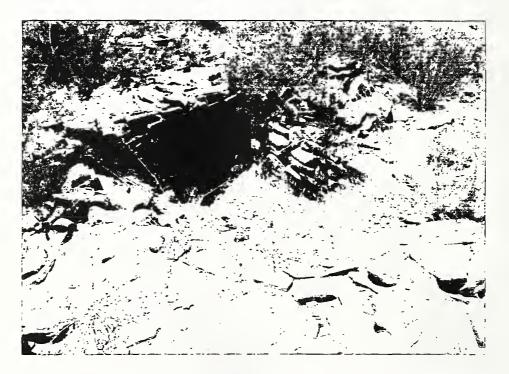
Figure 66. Looking north-northwest from Photo Station i at a pot hunted room. Digging attributed to Jones, Jones, Gevara. PMSVS Photo 10.26 was made in 1990.

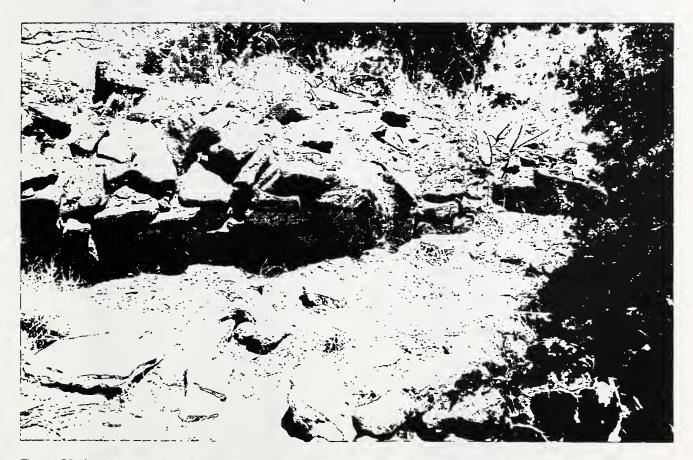
Figure 68. Looking south from Photo Station q at pot-hunted room, Mound B, Site AR-03-12-01-44 . This PMSVS Photo (10.35) was made in 1990.
